DEPARTMENT OF TRANSPORTATION

Contract #: 04-0120F4Cty: SF/ALA Rte: 80 PM: 13.2/13.9File #: 69.28**WELDING INSPECTION REPORT****Resident Engineer:**Pursell, Gary**Address:** 333 Burma Road**City:** Oakland, CA 94607**Report No:** WIR-003901**Date Inspected:** 13-Sep-2008**Project Name:** SAS Superstructure**OSM Arrival Time:** 1400**Prime Contractor:** American Bridge/Fluor Enterprises, a JV**OSM Departure Time:** 2230**Contractor:** Zhenhua Port Machinery Company, Ltd (ZPMC), Changxing Island **Location:** Shanghai, China**CWI Name:** Fu Yu Hong**CWI Present:** Yes No**Inspected CWI report:** Yes No N/A**Rod Oven in Use:** Yes No N/A**Electrode to specification:** Yes No N/A**Weld Procedures Followed:** Yes No N/A**Qualified Welders:** Yes No N/A**Verified Joint Fit-up:** Yes No N/A**Approved Drawings:** Yes No N/A**Approved WPS:** Yes No N/A**Delayed / Cancelled:** Yes No N/A**Bridge No:** 34-0006**Component:** OBG**Summary of Items Observed:**

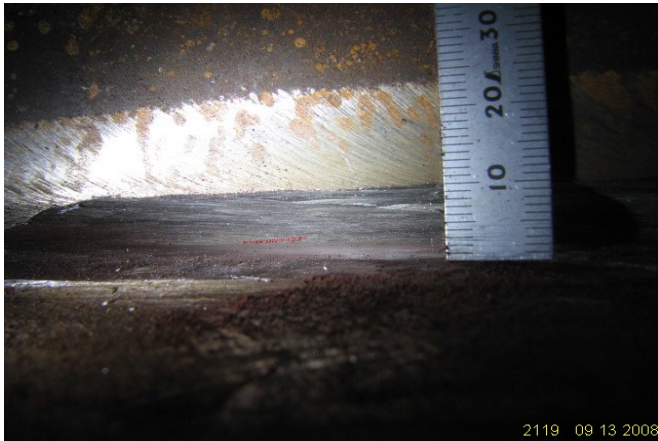
ZPMC ground thru the other side on the U ribs PJP repair on a localized area with approximately 1.1 mm of root gap by 10 mm of length at deck panel DP-050-001 weld # 9 Y location 6640 mm; See photograph below:

The QA inspector informed ZPMC that a critical weld repair (CWR) needed to be submitted due to the root gap excess the maximum allow of 0.5 mm. ZPMC did not perform the repair.

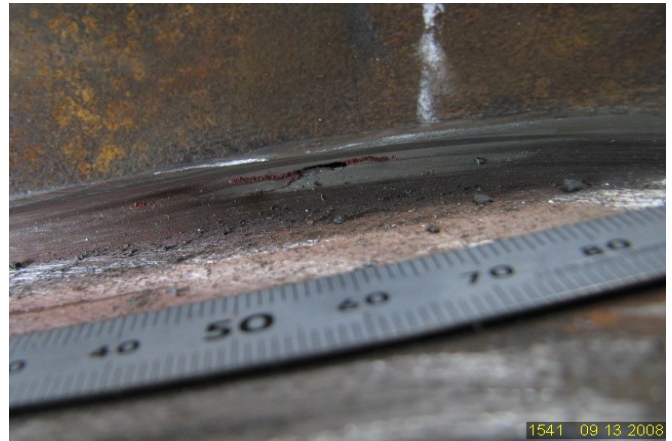
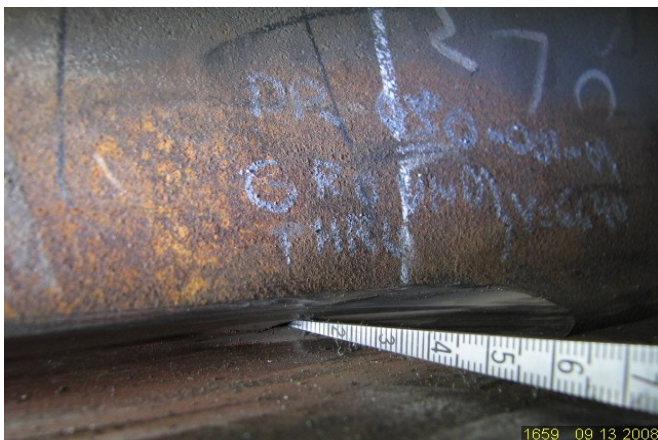
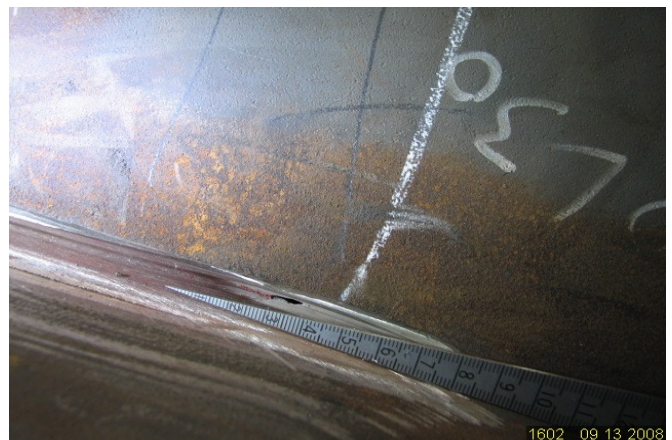
The QA inspector performed random visual verifications after ZPMC ground the U-ribs PJP at areas identified by Caltrans as crack like indications areas over the LOP areas (Second Time repairs). The QA inspector observed 3 crack like indications as observed below photos.
